NASA TECHNICAL NOTE

NASA TN D-3814

SECOND UNITED STATES MANNED THREE-PASS ORBITAL MISSION (MERCURY-ATLAS 7, SPACECRAFT 18)

DESCRIPTION AND PERFORMANCE ANALYSIS

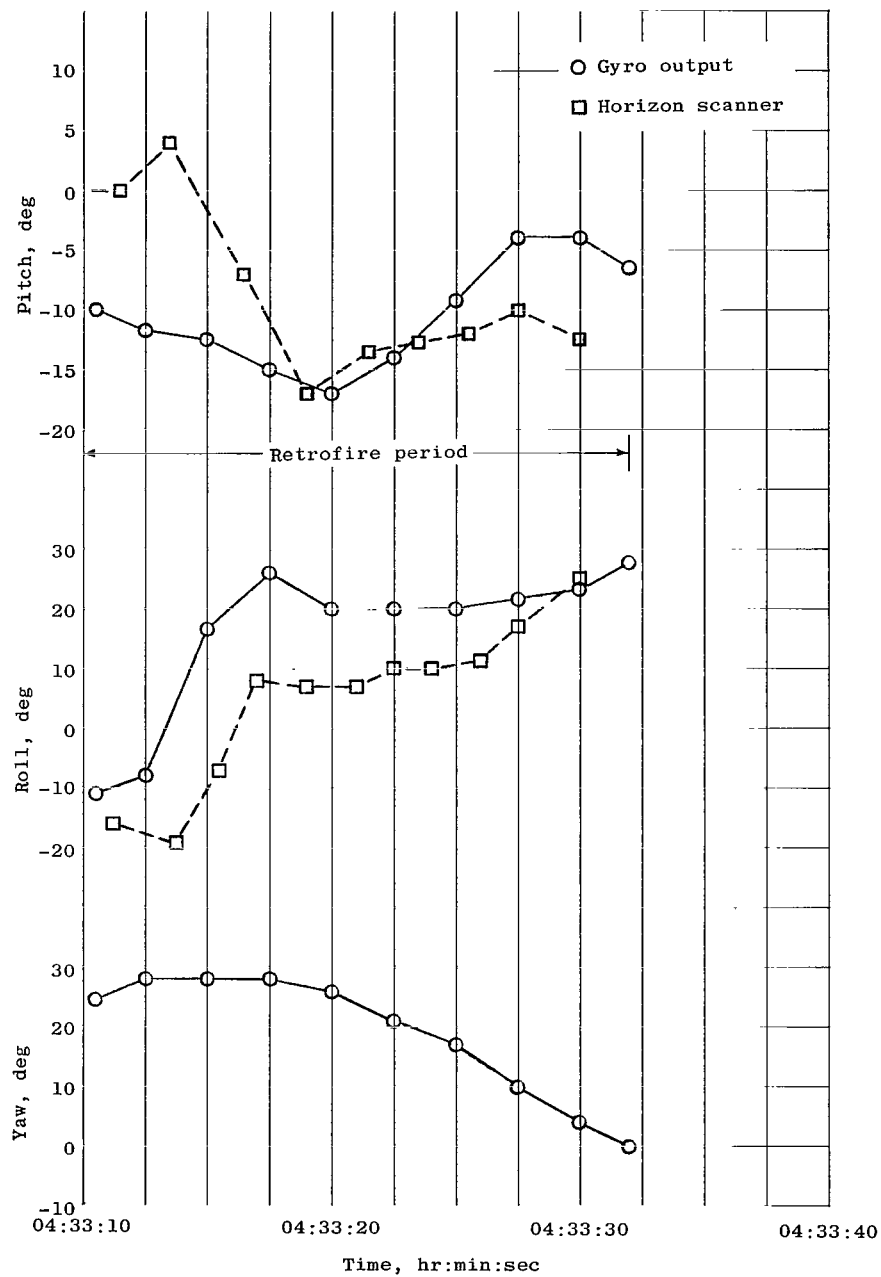
At various times during the orbital phase, the pitch horizon scanner output drifted without apparent spacecraft motion, as was found between 00:07:20 and 00:08:30, when an apparent slaving rate of 20° per minute would be required to duplicate the scanner-gyro-reference shift. The nominal gyro slaving rate is 8° per minute. From known astronaut reference positions during the orbital period, the comparable pitch horizon scanner output was observed to be in error by varying amounts between $+50^{\circ}$ and -20° .

Since the scanners were lost when the antenna canister was jettisoned during the normal landing sequence, postflight inspection and analysis of these units were impossible. However, postflight tests on the same type units have indicated three possible models of failure: (1) a capacitor anywhere in the circuit short circuited to ground; (2) a failure of the transistors (Q801 and/or Q802) in the flip-flop circuit and subsequent loss of the reference output and the loss of the pulse generating circuit and time reference, and (3) a failure of a transistor in the dc amplifier and subsequent reduction of the data factor by a factor of 10.

Figure 18.- Horizon scanner and gyro output during retrofire period for MA-7.

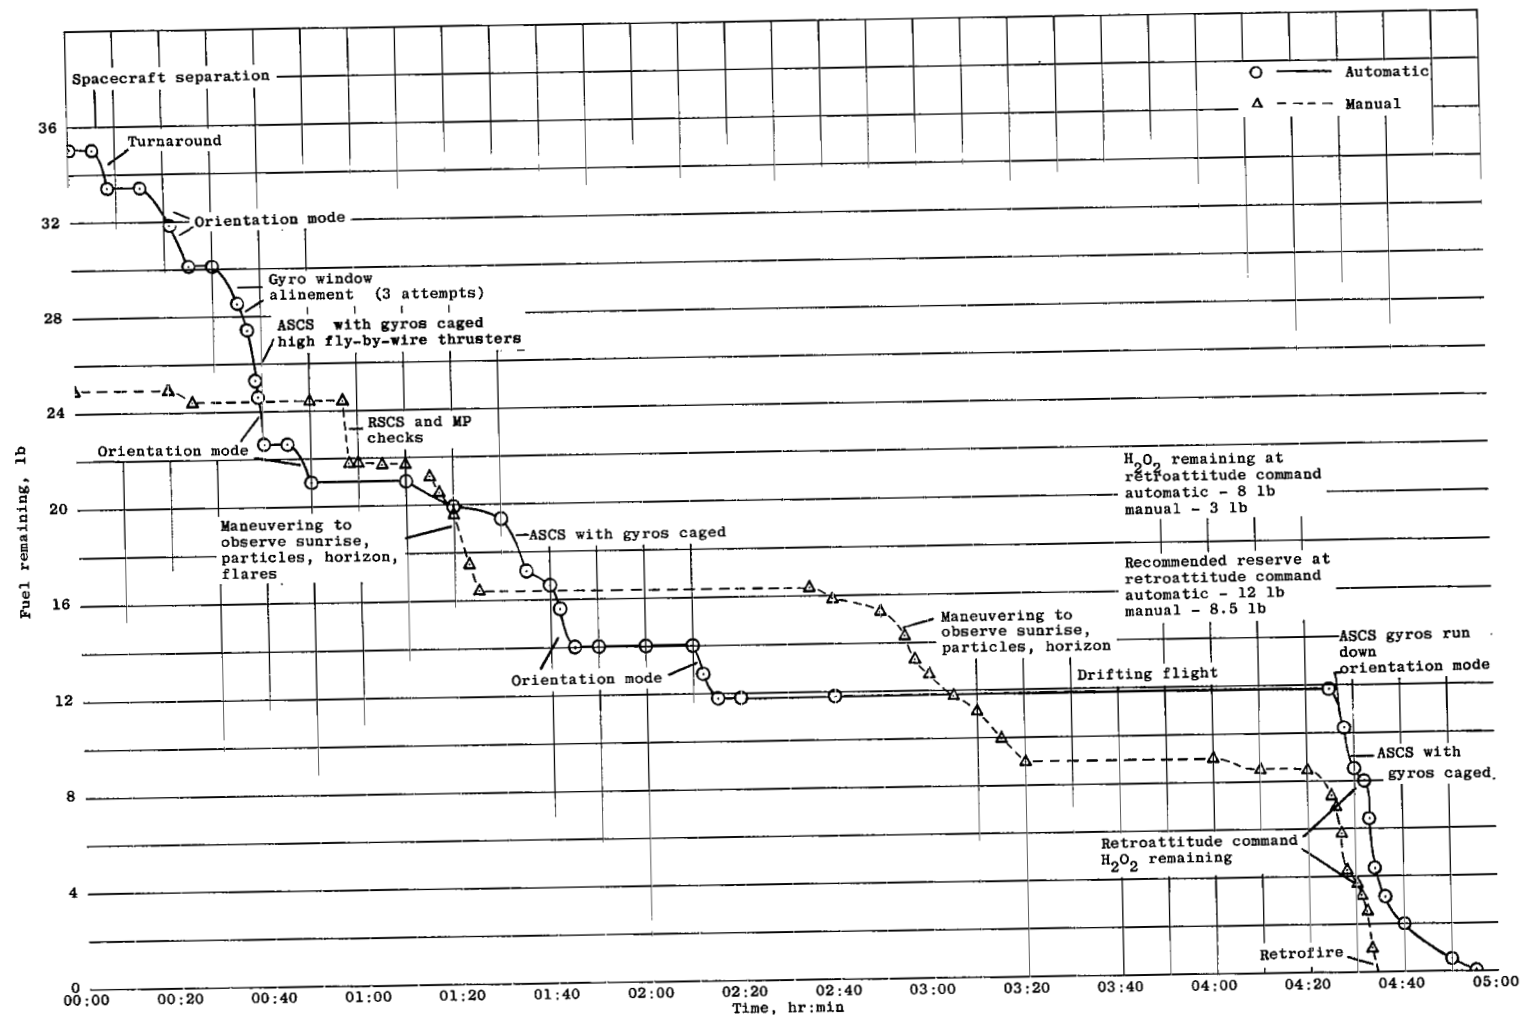
Manual control (FBW and MP) was used extensively during the flight. Approximately 17 minutes of the flight consisted of double authority control. The control system combinations utilized were FBW with MP and ASCS with MP. It should be noted that the high thrusters were actuated inadvertently a number of times by the astronaut while he was using FBW. The repeated use of the high thrusters, together with the use of double authority control, resulted in the unfavorable fuel usage rate, which can be seen in figure 19.

Figure 19.- H₂O₂ fuel usage.

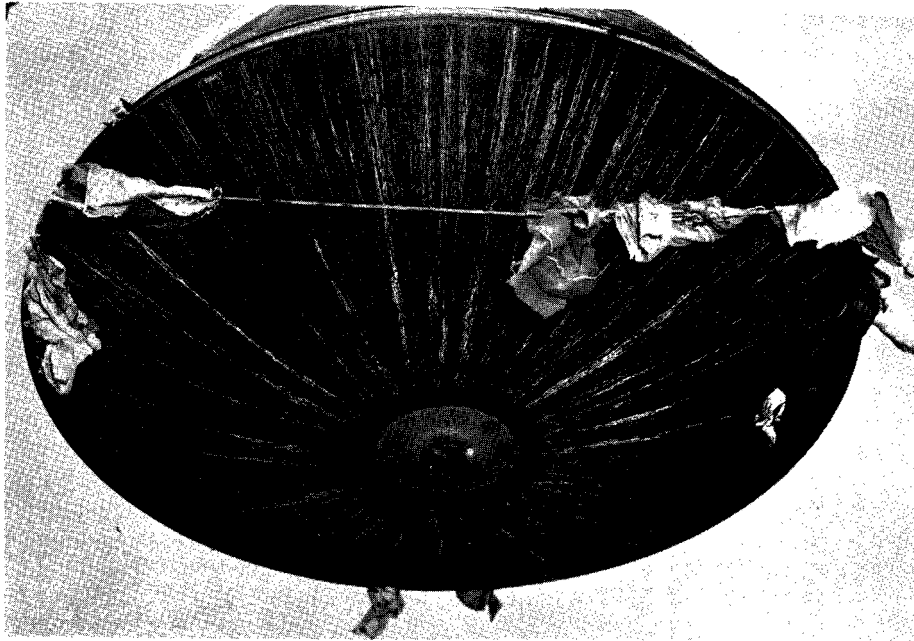
Figure 23.- Postflight photograph of Spacecraft 18 ablation shield.

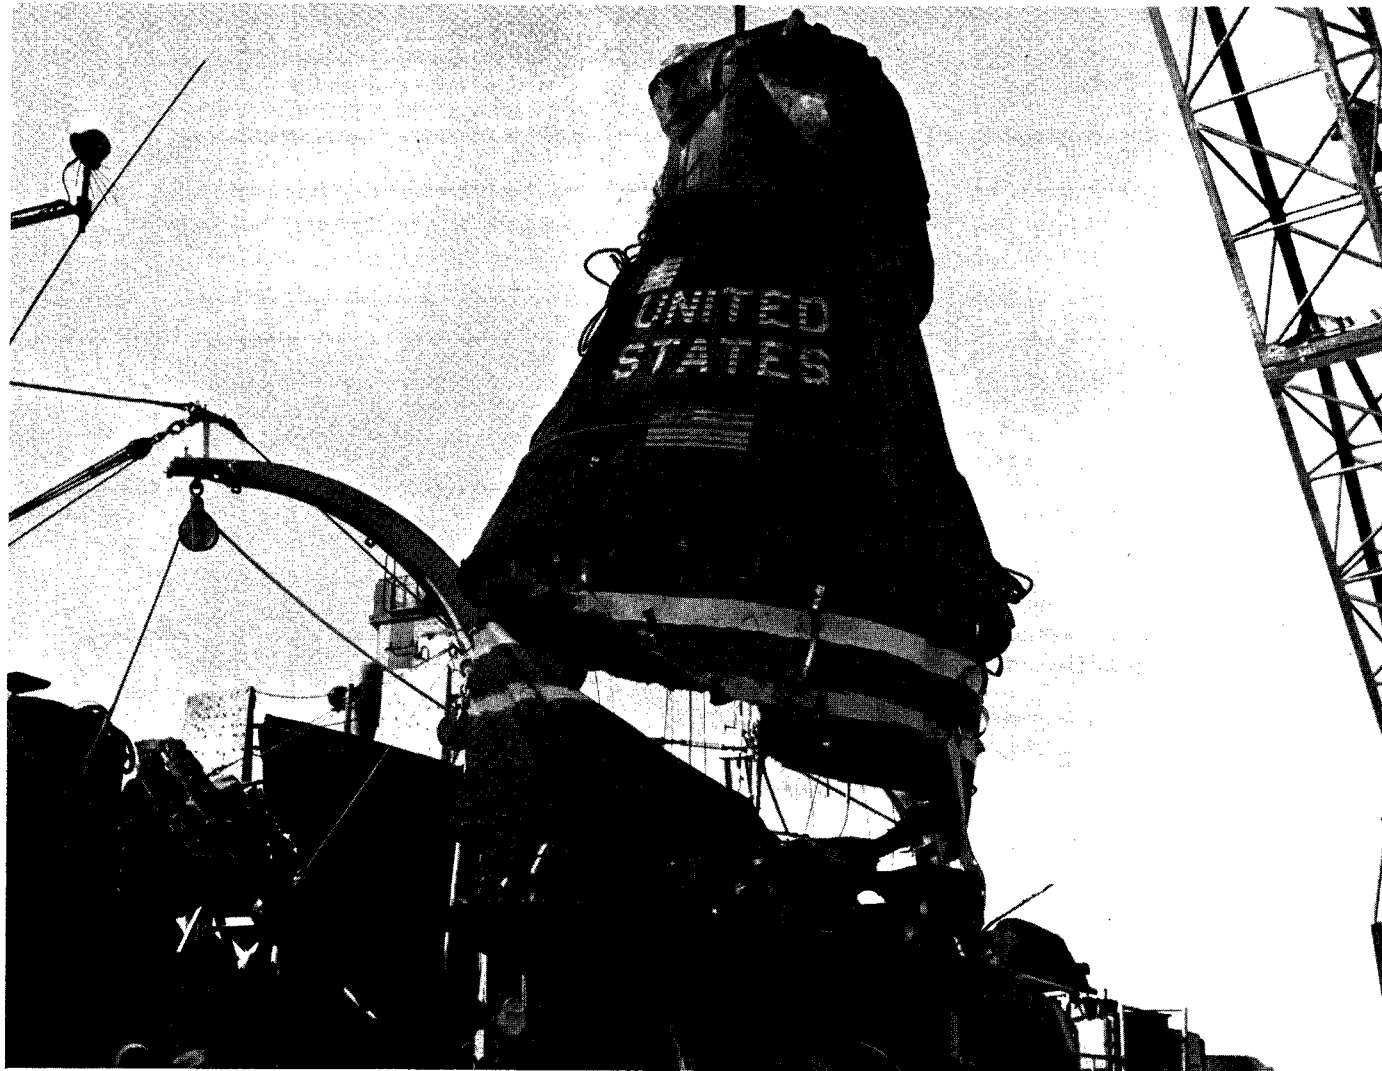
Figure 27.- Spacecraft 18 depicting postflight damage to landing bag and suspension straps.
